2003 ENGINE Engine Mechanical - Montero (3.8L)

Engine Mechanical - Montero (3.8L)

GENERAL DESCRIPTION

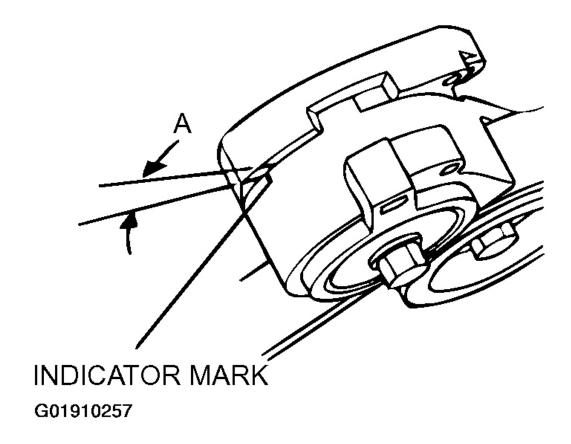
1. Check that the indicator mark of the auto-tensioner is located between the marks shown as "A" on the tensioner bracket.

<u>Fig. 6: Identifying Auto-Tensioner Indicator Mark Lies Position</u> Courtesy of MITSUBISHI MOTOR SALES OF AMERICA.

2. If the mark is located out of the space "A,", replace the drive belt.

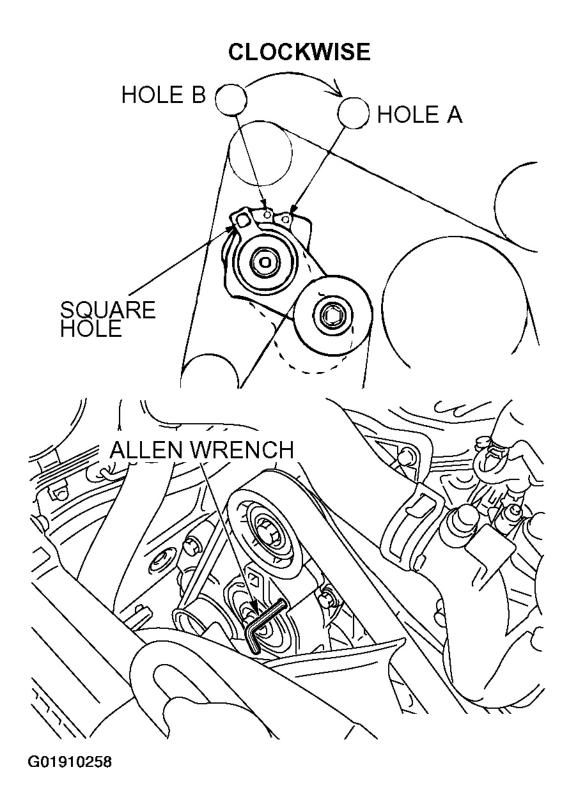
- 1. Run the engine at idling speed and then stop it to check whether the drive belt is centered on the autotensioner pulley.
- 2. Insert a 1/2 inch breaker bar into the square hole on the drive belt auto tensioner, and rotate it clockwise until the tensioner touches the stopper.
- 3. Align hole B with hole A, and insert a 5.0 mm (0.20 inch) Allen wrench to hold the tensioner. Then loosen the drive belt, and then remove the drive belt auto tensioner.
- 4. Move the auto-tensioner right and left by using a 1/2 inch breaker bar or similar tool to verify that it moves smoothly.

Fig. 7: Checking Auto-Tensioner Courtesy of MITSUBISHI MOTOR SALES OF AMERICA.

5. If some abnormality is found during the above mentioned check (1) and (3), replace the auto-tensioner.

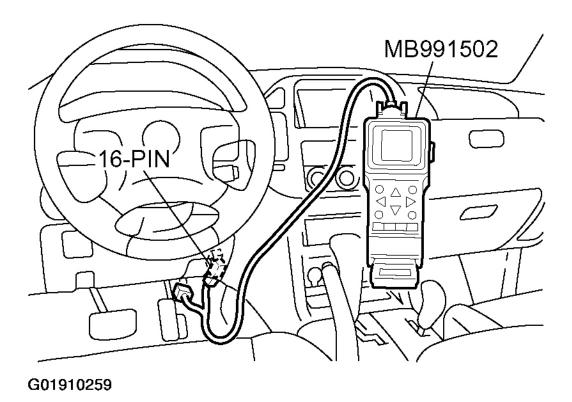
2. Connect scan tool MB991502 to the data link connector.

Fig. 8: Connecting Scan Tool To Data Link Connector (Ignition Timing Check) Courtesy of MITSUBISHI MOTOR SALES OF AMERICA.

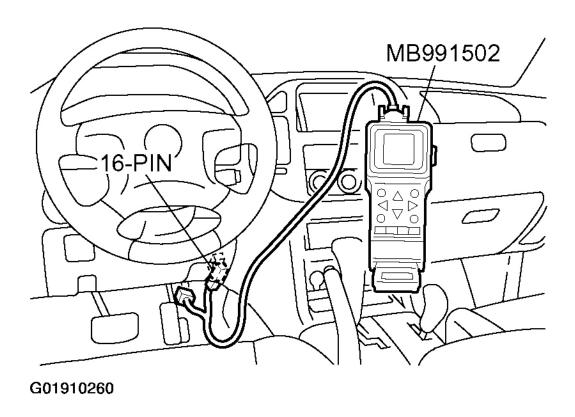
2. Connect scan tool MB991502 to the data link connector.

<u>Fig. 9: Connecting Scan Tool To Data Link Connector (Curb Idle Speed Check)</u> Courtesy of MITSUBISHI MOTOR SALES OF AMERICA.

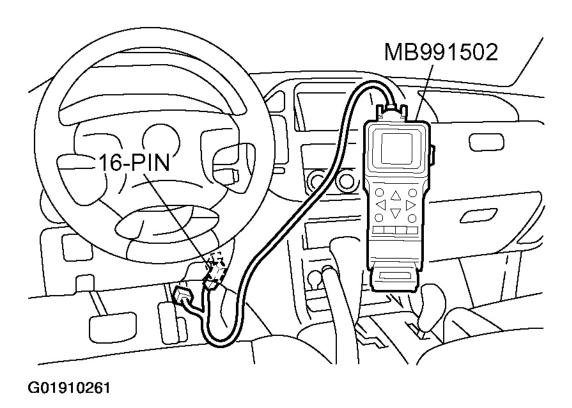
2. Connect scan tool MB991502 to the data link connector.

Fig. 10: Connecting Scan Tool To Data Link Connector (Idle Mixture Check) Courtesy of MITSUBISHI MOTOR SALES OF AMERICA.

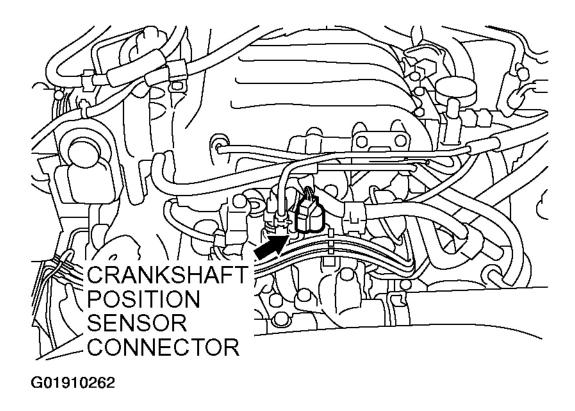
Fig. 11: Identifying Crankshaft Position Sensor Connector Location Courtesy of MITSUBISHI MOTOR SALES OF AMERICA.

- 1. Before inspection, check that the engine oil, starter and battery are normal. Also, set the vehicle in the following condition:
 - Engine coolant temperature: 80 95°C (176 203°F)
 - Lights, and all accessories: OFF
 - Transmission: P range
- 2. Disconnect the spark plug cables.
- 3. Remove all of the spark plugs.
- 4. Disconnect the crankshaft position sensor connector.

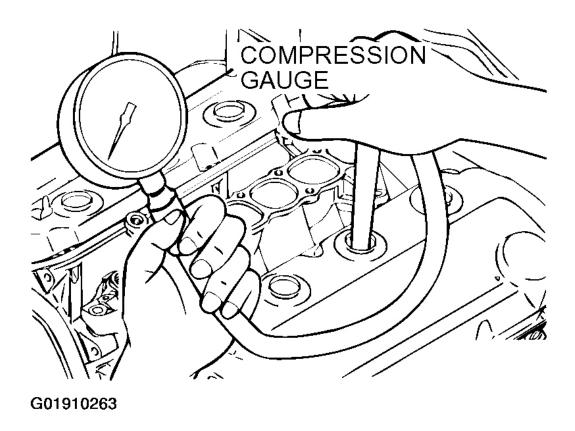
8. Measure the compression pressure for all the cylinders, and check that the pressure differences of the cylinders are below the limit.

<u>Fig. 12: Measuring Compression Pressure</u> Courtesy of MITSUBISHI MOTOR SALES OF AMERICA.

Limit: 98 kPa (14 psi)

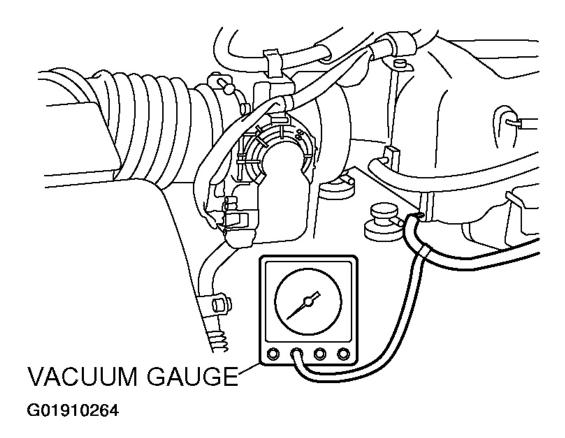
Minimum limit: 60 kPa (18 in Hg)

Fig. 13: Checking Manifold Vacuum
Courtesy of MITSUBISHI MOTOR SALES OF AMERICA.

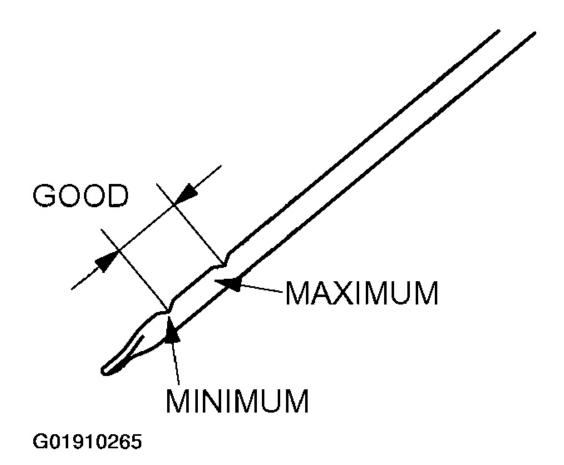
1. Check engine oil and add or change oil if required.

<u>Fig. 14: Identifying Engine Oil OK Position On Dipstick</u> Courtesy of MITSUBISHI MOTOR SALES OF AMERICA.

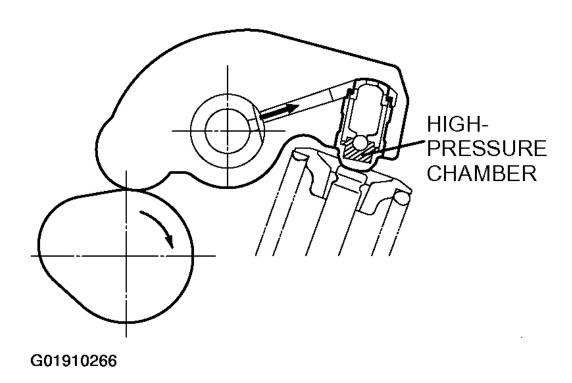
Fig. 15: Identifying Lash Adjuster & Valve Train Components Courtesy of MITSUBISHI MOTOR SALES OF AMERICA.

adjuster from the above causes, air in the high pressure chamber is compressed excessively while the valve is opened, resulting in an abnormal noise when the valve closes. This is the same phenomenon as that observed when the valve clearance has become excessive. The lash adjuster can resume normal function when air entered the lash adjuster is

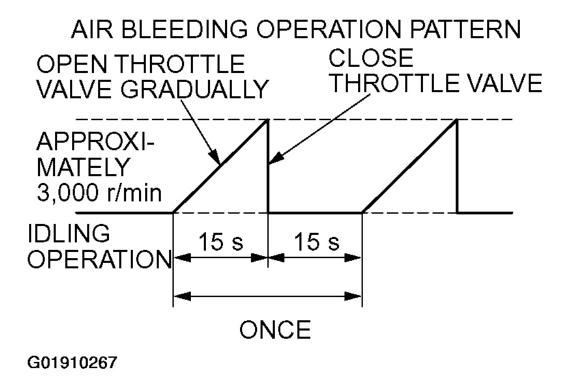
3. Repeat the operation pattern, shown in left figure, at no load to check for abnormal noise. (Usually the abnormal noise is eliminated after repetition of the operation 10 to 30 times. If, however, no change is observed in the level of abnormal noise after repeating the operation more than 30 times, suspect that the abnormal noise is due to some other factors.

<u>Fig. 16: Air Bleeding Operation Pattern</u> Courtesy of MITSUBISHI MOTOR SALES OF AMERICA.

- 4. After elimination of abnormal noise, repeat the operation shown in left figure five more times.
- 5. Run the engine at idle for one to three minutes to make sure that the abnormal noise has been eliminated.

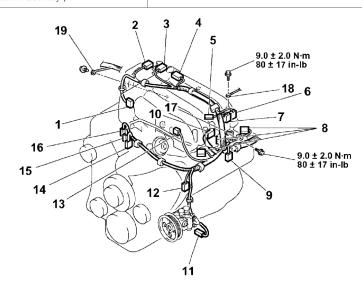
- THROTTLE POSITION SENSOR CONNECTOR
- 2. EGR CONNECTOR
- 3. RIGHT BANK HEATED OXYGEN SENSOR CONNECTOR
- MANIFOLD DIFFERENTIAL PRESSURE SENSOR
- 5. NOISE CONDENSER CONNECTOR
- CONTROL WIRING HARNESS AND CAMSHAFT POSITION SENSOR WIRING HARNESS CONNECTOR
- 7. KNOCK SENSOR CONNECTOR
- 8. IGNITION COIL CONNECTOR
- 9. LEFT BANK HEATED OXYGEN SENSOR CONNECTOR
- 10. CONTROL WIRING HARNESS AND INJECTION WIRING HARNESS COMBINATION CONNECTOR

Fig. 17: Engine Assembly Removing Procedure & Torque Specifications (1 Of 2) Courtesy of MITSUBISHI MOTOR SALES OF AMERICA.

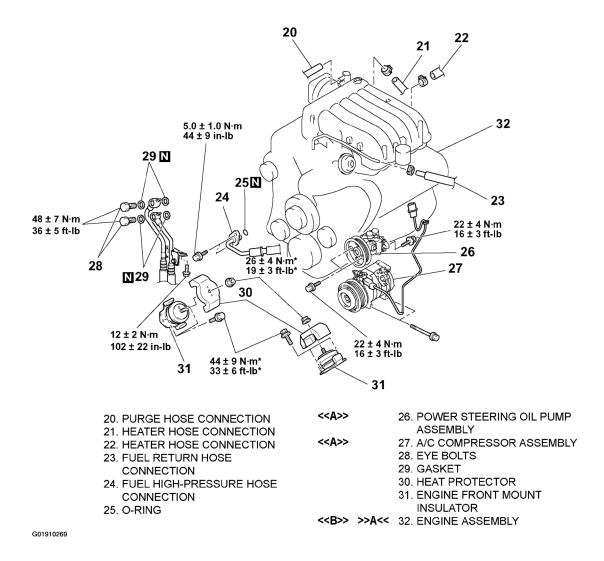
Fig. 18: Engine Assembly Removing Procedure & Torque Specifications (2 Of 2) Courtesy of MITSUBISHI MOTOR SALES OF AMERICA.

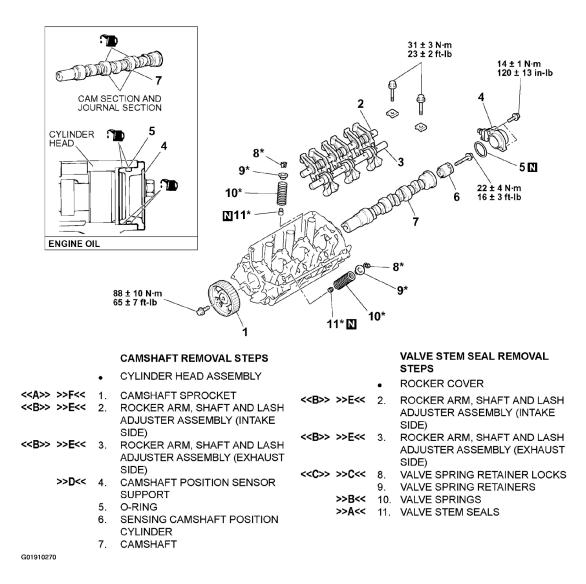
CAUTION: Remove and assemble the marked parts in each cylinder unit.

Fig. 19: Removing Camshaft & Valve Stem Seals & Torque Specifications Courtesy of MITSUBISHI MOTOR SALES OF AMERICA.

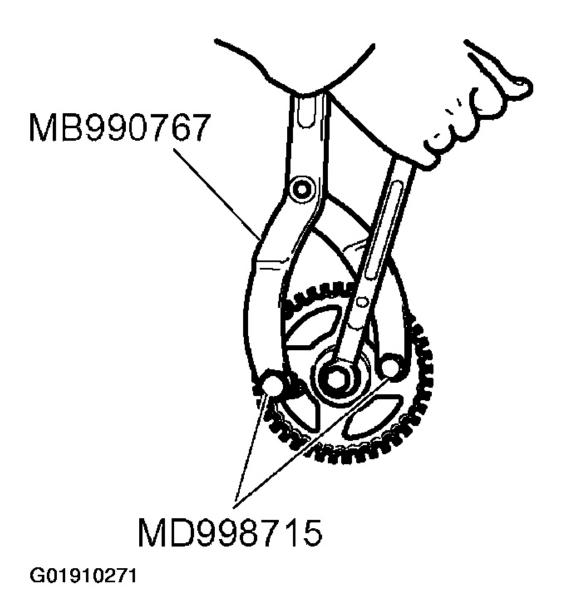
Use special tools MD998715 and MB990767 to remove the camshaft sprocket.

<u>Fig. 20: Removing Camshaft Sprocket</u> Courtesy of MITSUBISHI MOTOR SALES OF AMERICA.

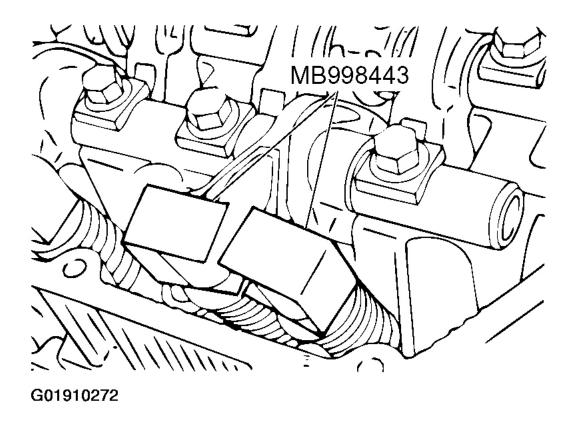
Fig. 21: Installed Position Of Lash Adjuster Special Tool Courtesy of MITSUBISHI MOTOR SALES OF AMERICA.

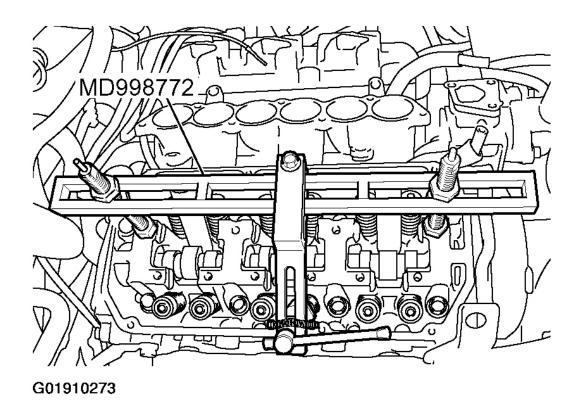
Use special tool MD998772 to compress the valve spring, and remove the valve spring retainer locks.

<u>Fig. 22: Compressing Valve Spring Using Special Tool</u> Courtesy of MITSUBISHI MOTOR SALES OF AMERICA.

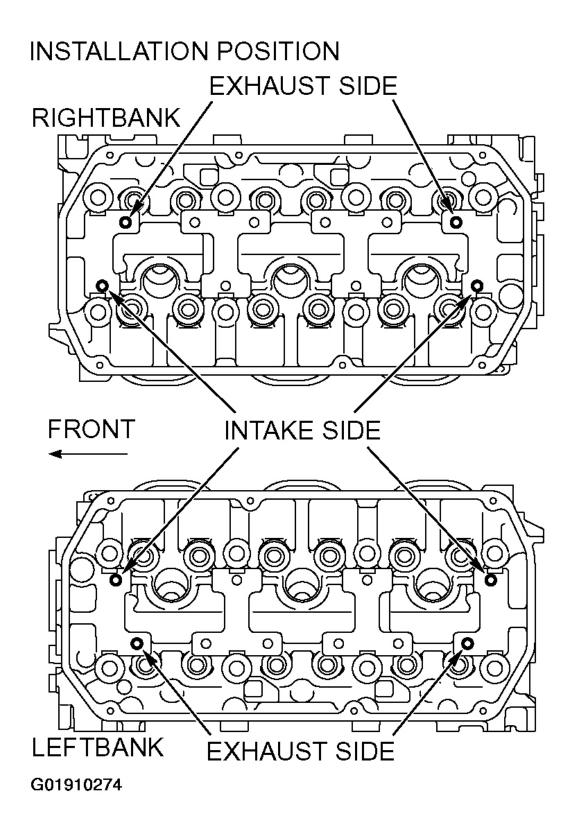
NOTE: Installation position of valve spring compressor special tool (MD998772) is different between exhaust side and intake side.

Fig. 23: Identifying Installation Position For Valve Spring Compressor Courtesy of MITSUBISHI MOTOR SALES OF AMERICA.

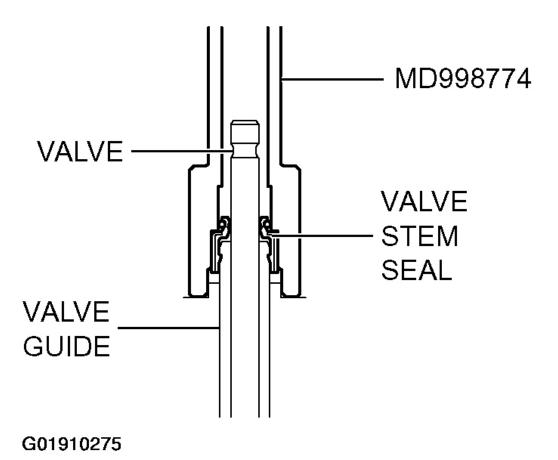
- Valve stem seals cannot be reused.
- Special tool MD998774 must be used to install the valve stem seal. Improper installation could result in oil leaking past the valve guide.
- 2. Use special tool MD998774 to fill a new valve stem seal in the valve guide using the valve stem area as a guide.

<u>Fig. 24: Installing Valve Stem Seal</u> Courtesy of MITSUBISHI MOTOR SALES OF AMERICA.

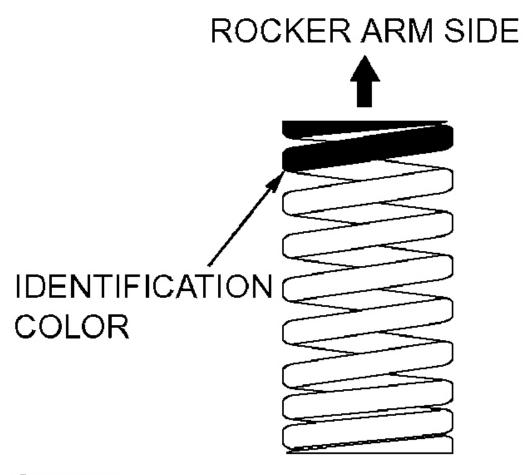
Install the valve springs with its identification color painted end facing the rocker arm.

Fig. 25: Identifying Correct Installation Position Of Valve Springs Courtesy of MITSUBISHI MOTOR SALES OF AMERICA.

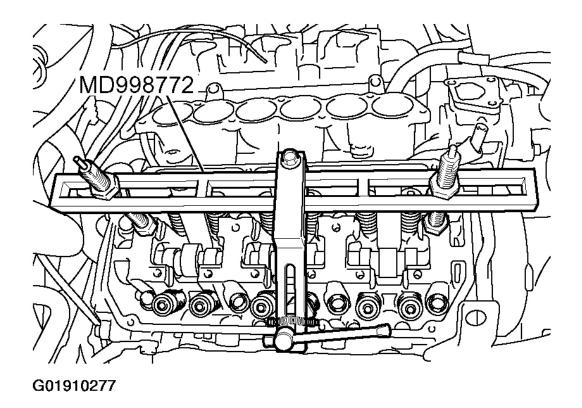
Use special tool MD998772 to compress the valve spring in the same manner as removal.

<u>Fig. 26: Compressing Valve Spring Using Special Tool</u>
Courtesy of MITSUBISHI MOTOR SALES OF AMERICA.

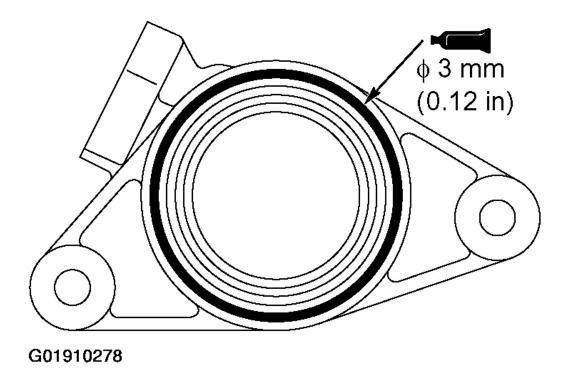
3. Install the camshaft position sensor support to the cylinder head.

Fig. 27: Applying Sealant To Camshaft Position Sensor Support Flange Courtesy of MITSUBISHI MOTOR SALES OF AMERICA.

CAUTION: Then wait at least one hour. Never start the engine or let engine oil or coolant touch the adhesion surface during that time.

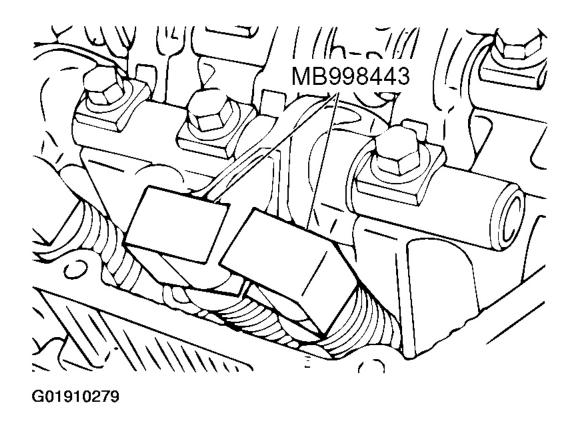
Fig. 28: Installing Rocker Arm, Shaft And Lash Adjuster Using Special Tool Courtesy of MITSUBISHI MOTOR SALES OF AMERICA.

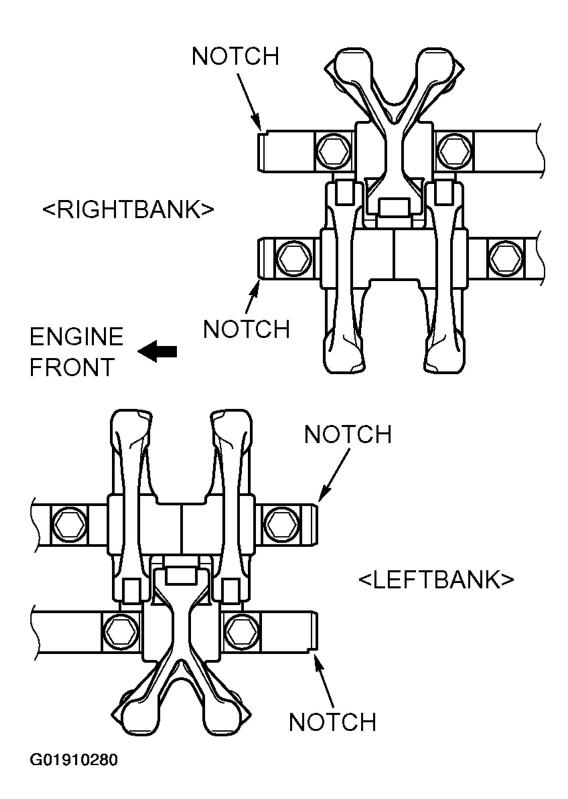
4. Check that notches in the each rocker shaft are facing the direction shown in the illustration.

Fig. 29: Identifying Correct Rocker Shaft Assembly Position Courtesy of MITSUBISHI MOTOR SALES OF AMERICA.

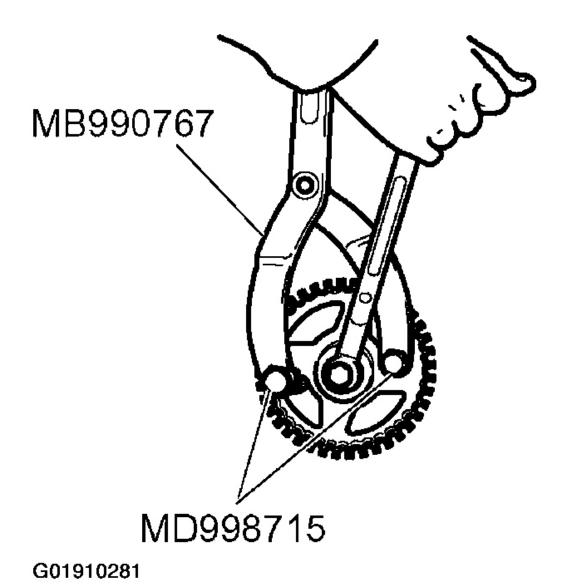
- 1. Use special tools MD998715 and MB990767 in the same way as during removal to install the camshaft sprocket.
- 2. Tighten the camshaft sprocket mounting bolt to the specified torque.

Tightening torque: 88 + -10 N.m (65 + -7 ft-lb)

<u>Fig. 30: Installing Camshaft Sprocket</u> Courtesy of MITSUBISHI MOTOR SALES OF AMERICA.

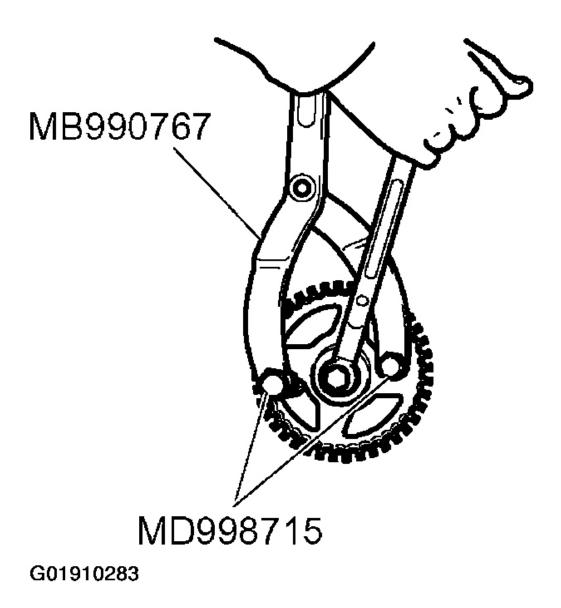
Use special tools MD998715 and MB990767 to remove the camshaft sprocket.

<u>Fig. 32: Removing Camshaft Sprocket</u> Courtesy of MITSUBISHI MOTOR SALES OF AMERICA.

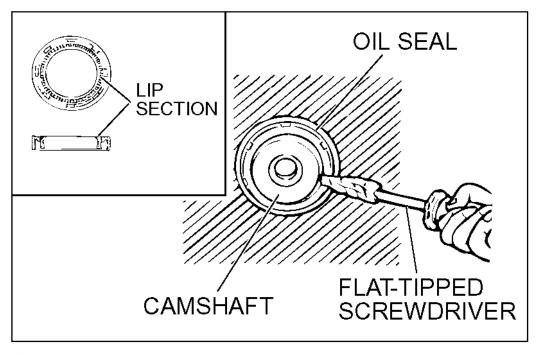
2. Cover the end of a flat-tipped screwdriver with a shop towel and insert into the notched section of the oil seal, and pry out the oil seal to remove it.

Fig. 33: Prying Out Camshaft Oil Seal Courtesy of MITSUBISHI MOTOR SALES OF AMERICA.

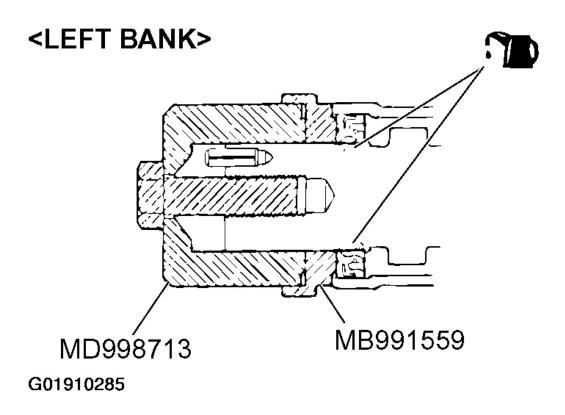
- 1. Apply engine oil to the camshaft oil seal lip.
- 2. Use special tools MD998713 and MB991559 to press-fit the camshaft oil seal.

<u>Fig. 34: Installing Camshaft Oil Seal (Left Bank)</u> Courtesy of MITSUBISHI MOTOR SALES OF AMERICA.

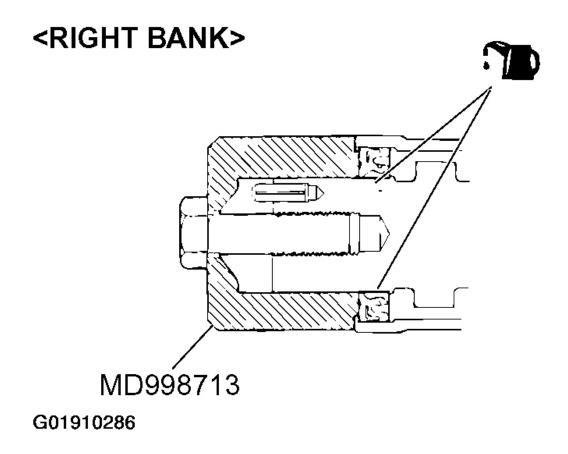
Fig. 35: Installing Camshaft Oil Seal (Right Bank)
Courtesy of MITSUBISHI MOTOR SALES OF AMERICA.

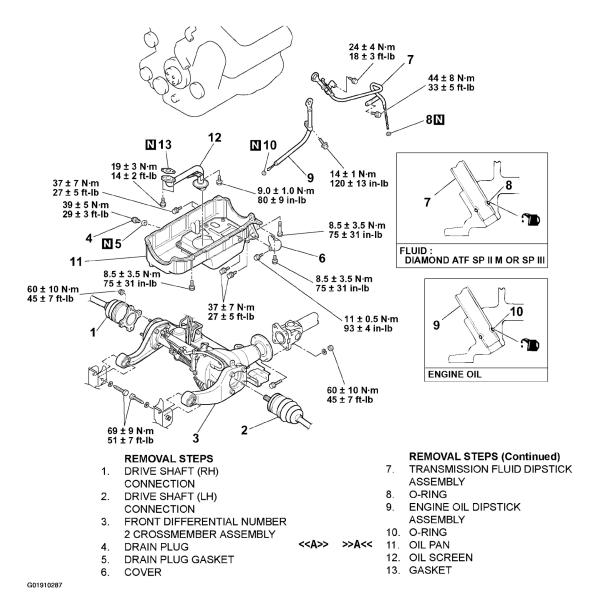
<u>Fig. 36: Removing Oil Pan & Oil Screen & Torque Specifications</u> Courtesy of MITSUBISHI MOTOR SALES OF AMERICA.

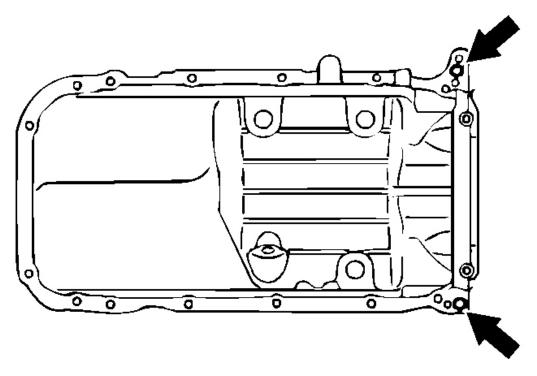
2. Screw the bolts (M10) securing the oil pan to the transmission assembly in the illustrated bolt holes, then remove the oil pan.

Fig. 37: Removing Oil Pan
Courtesy of MITSUBISHI MOTOR SALES OF AMERICA.

CAUTION: Do not use the oil pan remover (MD998727). It will damage the oil pan (aluminum made).

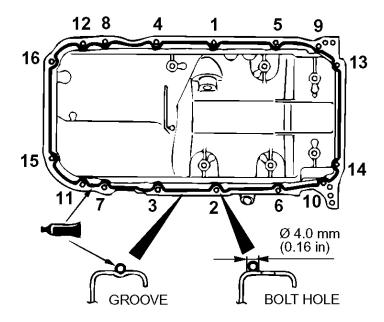
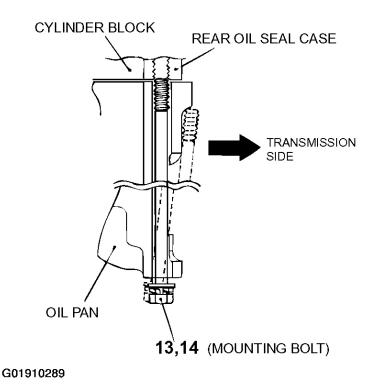
5. Tighten the bolts in order of the numbers shown in the illustration.

<u>Fig. 38: Identifying Sealant Application & Oil Pan Bolt Tightening Sequence</u> Courtesy of MITSUBISHI MOTOR SALES OF AMERICA.

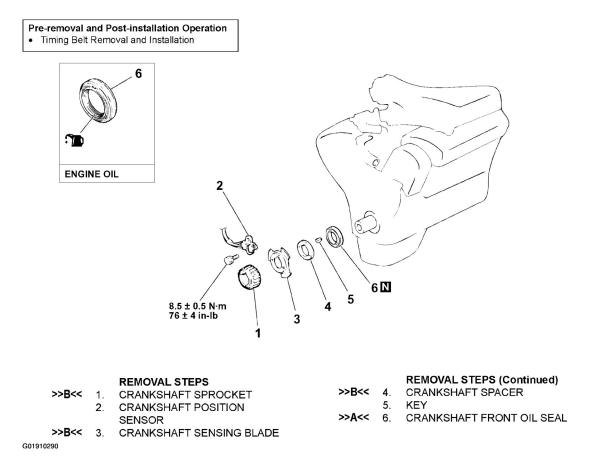
Fig. 39: Removing Front Crankshaft Oil Seal Courtesy of MITSUBISHI MOTOR SALES OF AMERICA.

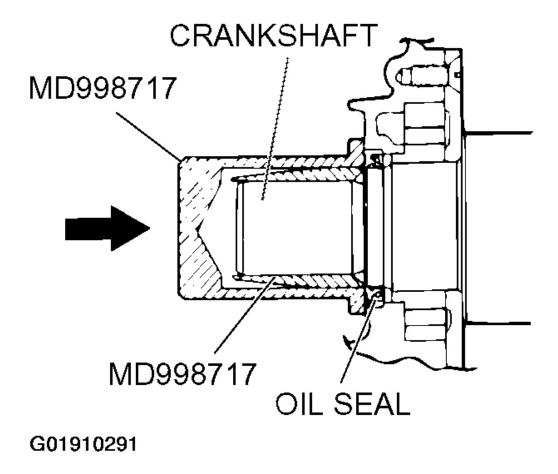
- 1. Apply a small amount of engine oil to the oil seal lip and then insert.
- 2. Using special tool MD998717, tap the oil seal into the front case.

<u>Fig. 40: Installing Front Oil Seal Into Front Case</u> Courtesy of MITSUBISHI MOTOR SALES OF AMERICA.

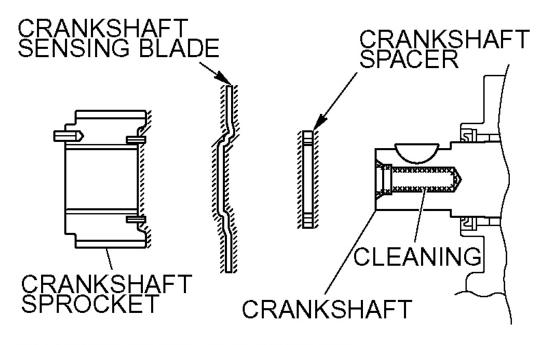
To prevent the crankshaft pulley mounting bolt from loosening, degrease or clean the crankshaft, the crankshaft spacer, the crankshaft sensing blade and the crankshaft at the shown positions.

SHADED PART: DEGREASE

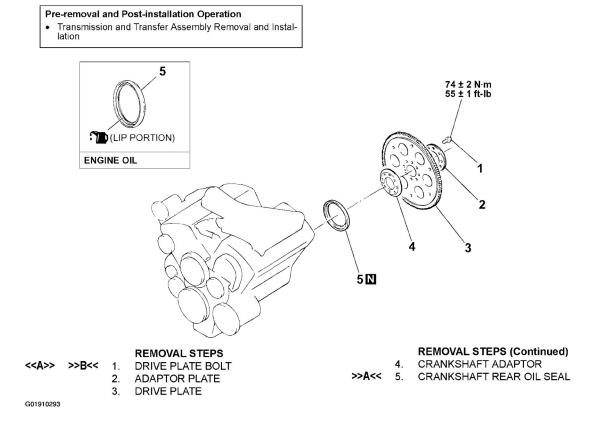
<u>Fig. 42: Removing Crankshaft Rear Oil Seal</u> Courtesy of MITSUBISHI MOTOR SALES OF AMERICA.

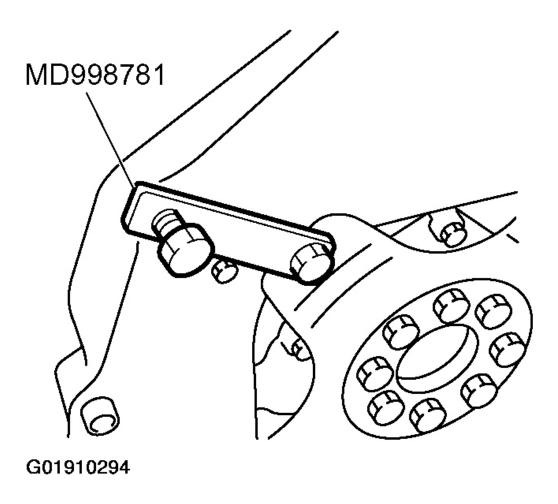
Use special tool MD998781 to secure the drive plate and remove the drive plate bolt.

<u>Fig. 43: Securing Drive Plate Use Special Tool</u> Courtesy of MITSUBISHI MOTOR SALES OF AMERICA.

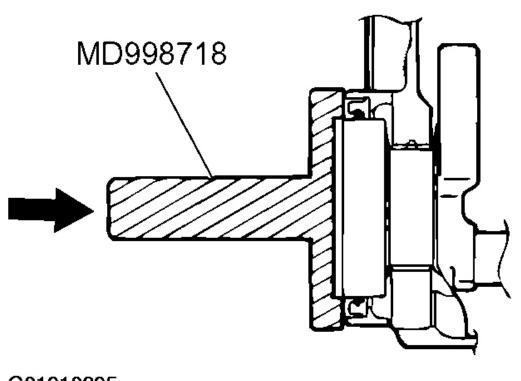
- 1. Apply a small amount of engine oil to the entire circumference of the oil seal lip.
- 2. Use special tool MD998718 to tap in the oil seal as shown in the illustration.

<u>Fig. 44: Installing Rear Oil Seal</u> Courtesy of MITSUBISHI MOTOR SALES OF AMERICA.

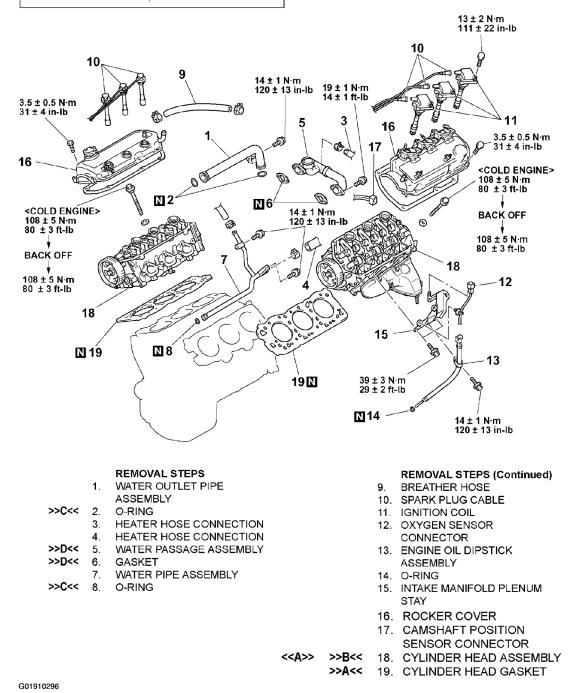
Fig. 45: Removing & Installing Cylinder Head Gasket & Torque Specifications Courtesy of MITSUBISHI MOTOR SALES OF AMERICA.

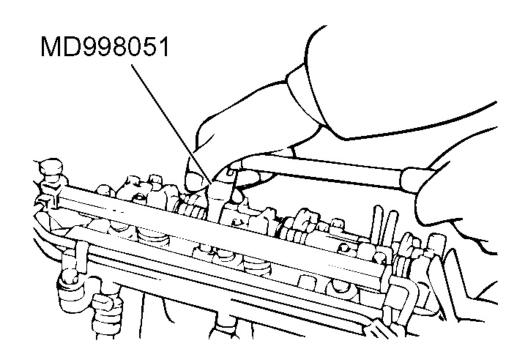
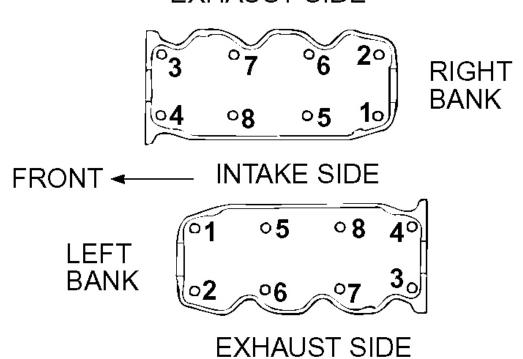
G01910297

Use special tool MD998051 to tighten each bolt two or three steps in the order shown in the illustration.

EXHAUST SIDE

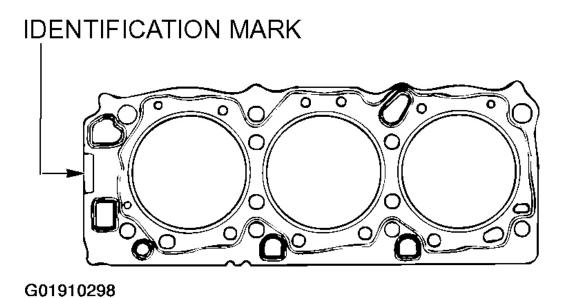
- 1. Degrease the cylinder head and cylinder block gasket mounting surfaces.
- 2. Make sure that the gasket has the proper identification mark for the engine.
- 3. Lay the cylinder head gasket on the cylinder block with the identification mark at the front top.

Fig. 47: Identifying Cylinder Head Gasket Correct Installed Position Courtesy of MITSUBISHI MOTOR SALES OF AMERICA.

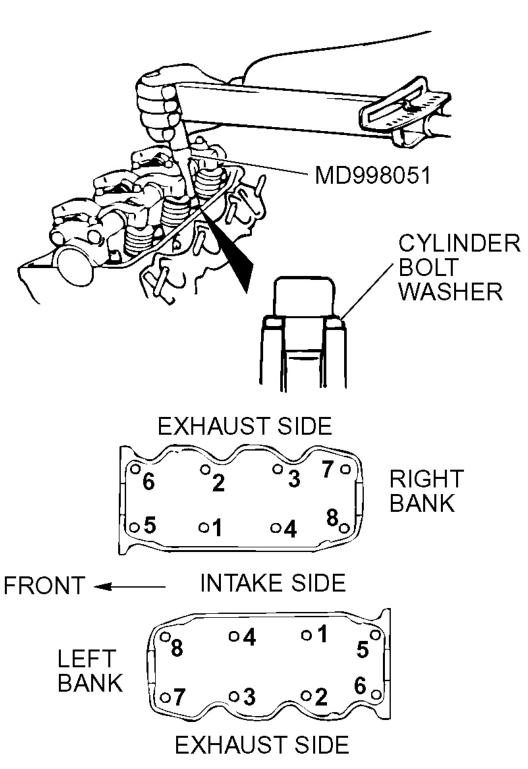
G01910299

CAUTION: Install the head bolt washers with the beveled side facing upwards as shown in the illustration.

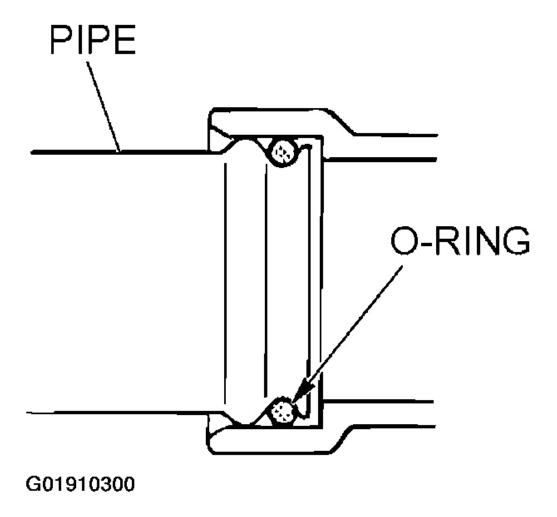
Install the O-ring into the groove of the pipe, and then apply water around the O-ring.

<u>Fig. 49: Identifying O-Ring Installation Position In Pipe Groove</u> Courtesy of MITSUBISHI MOTOR SALES OF AMERICA.

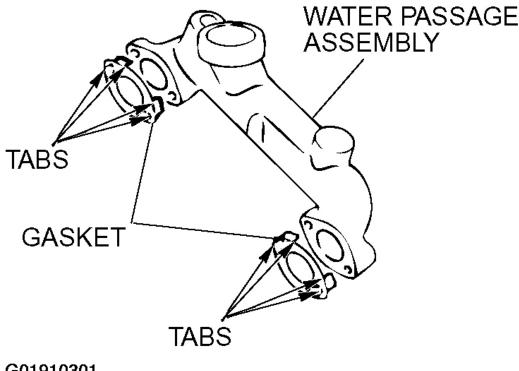
Bend the tabs onto the water passage assembly. Then install the water passage assembly to the cylinder head so that the gasket doesn't slip.

<u>Fig. 50: Installing Water Passage Assembly Gaskets</u> Courtesy of MITSUBISHI MOTOR SALES OF AMERICA.

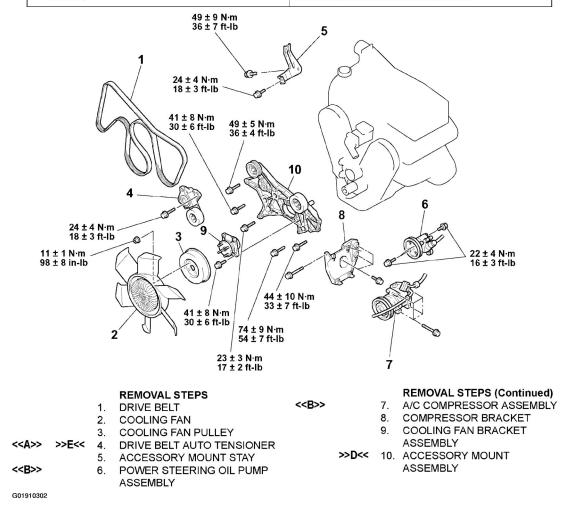
Fig. 51: Removing & Installing Timing Belt & Torque Specifications (1 Of 2) Courtesy of MITSUBISHI MOTOR SALES OF AMERICA.

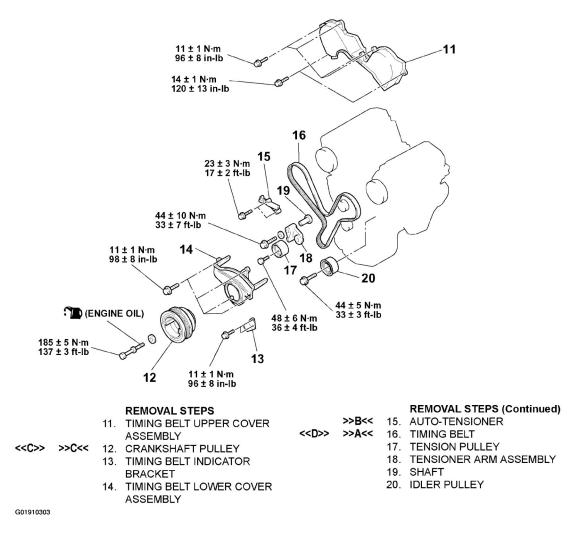
<u>Fig. 52: Removing & Installing Timing Belt & Torque Specifications (2 Of 2)</u> Courtesy of MITSUBISHI MOTOR SALES OF AMERICA.

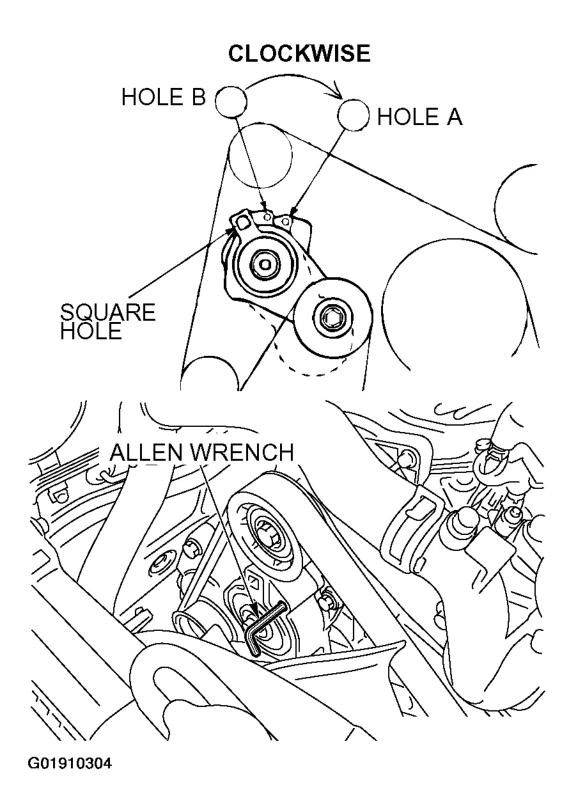
- 1. Insert a 12.7 mm (1/2 inch) breaker bar into the square hole on the drive belt auto tensioner, and rotate it clockwise until the tensioner touches the stopper.
- 2. Align hole B with hole A, and insert a 5.0 mm (0.20 inch) Allen wrench to hold the tensioner. Then loosen the drive belt, and then remove the drive belt auto tensioner.

<u>Fig. 53: Removing Drive Belt & Auto Tensioner</u> Courtesy of MITSUBISHI MOTOR SALES OF AMERICA.

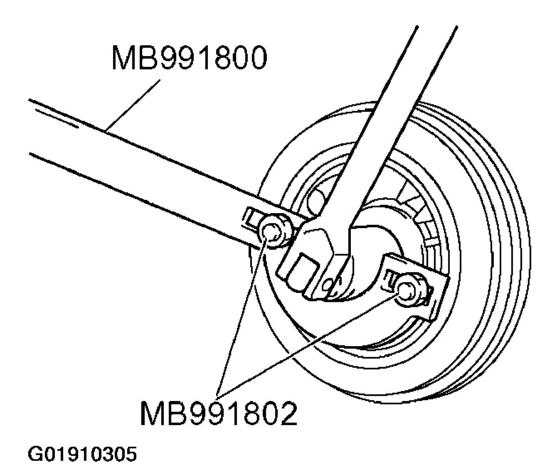
Use special tools MB991800 and MB991802 to remove the crankshaft pulley from the crankshaft.

Fig. 54: Removing Crankshaft Pulley From Crankshaft Courtesy of MITSUBISHI MOTOR SALES OF AMERICA.

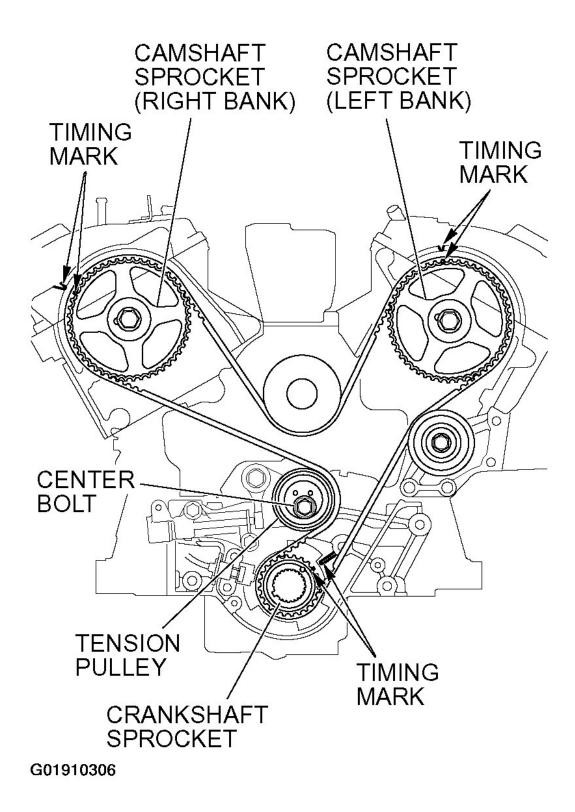
- 1. Turn the crankshaft clockwise to align each timing mark and to set the number 1 cylinder to compression top dead center.
- 2. If the timing belt is to be reused, chalk mark the flat side of the belt with an arrow indicating the clockwise direction.
- 3. Loosen the center bolt of the tension pulley, and then remove the timing belt.

Fig. 55: Identifying Timing Belt Alignment Marks

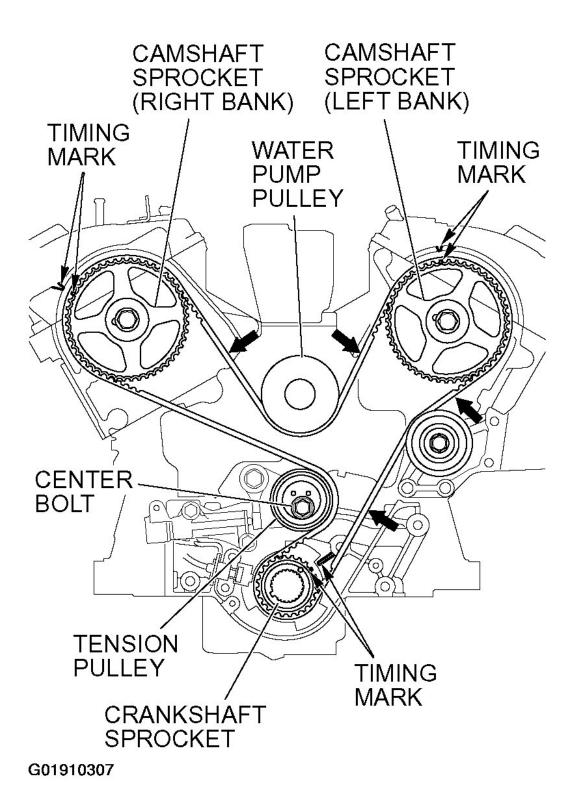
CAUTION: The camshaft sprocket (right bank) can turn easily due to the spring force applied, so be careful not to get your fingers caught.

Fig. 56: Installing Timing Belt

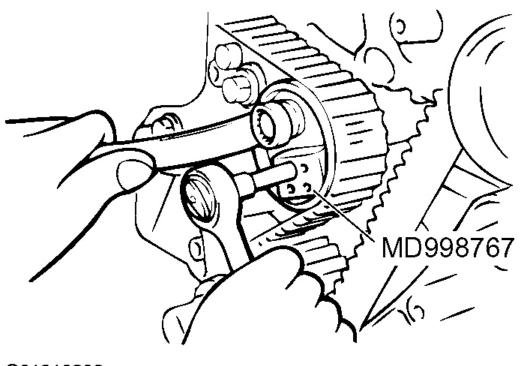
4. Use special tool MD998767 to push the tensioner pulley into the timing belt, and then temporarily tighten the center bolt.

<u>Fig. 57: Pre-Tensioning Timing Belt</u> Courtesy of MITSUBISHI MOTOR SALES OF AMERICA.

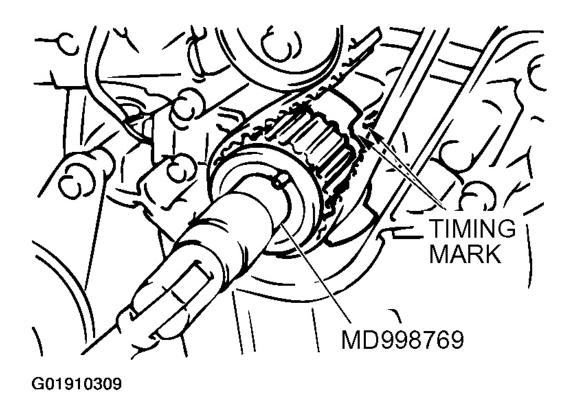
5. Use special tool MD998769 to turn the crankshaft 1/4 turn counterclockwise and then turn it again clockwise until the timing marks are aligned.

<u>Fig. 58: Aligning Crankshaft Timing Mark</u> Courtesy of MITSUBISHI MOTOR SALES OF AMERICA.

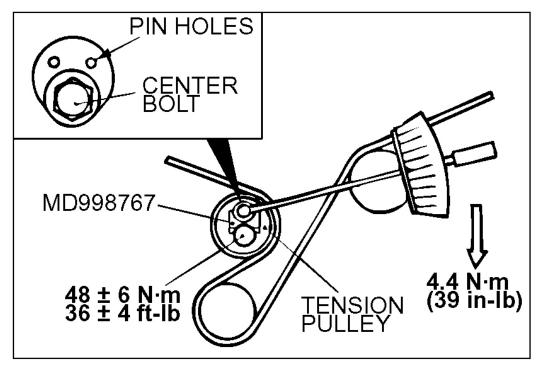
- 6. Loosen the center bolt of the tensioner pulley. Use special tool MD998767 and a torque wrench to apply the standard torque to the timing belt as shown in the illustration. Then tighten the center bolt to the specified torque.
 - Standard value: 4.4 N.m (39 in-lb) < Timing belt tension torque >
 - Tightening torque: 48 +/- 6 N.m (36 +/- 4 ft-lb)

Fig. 59: Tensioning Timing Belt Courtesy of MITSUBISHI MOTOR SALES OF AMERICA.

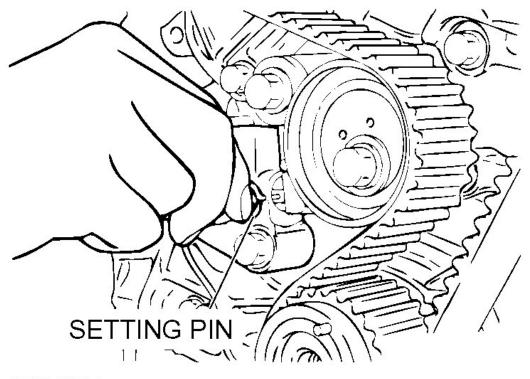
- Remove the setting pin that has been inserted into the auto-tensioner.
- Turn the crankshaft two turns clockwise to align the timing marks.

Fig. 60: Removing Setting Pin From Auto-Tensioner Courtesy of MITSUBISHI MOTOR SALES OF AMERICA.

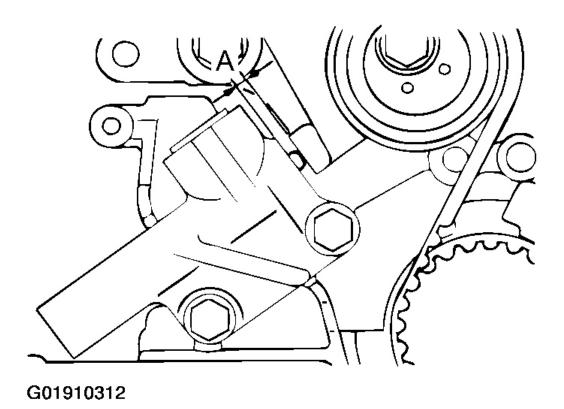
<u>Fig. 61: Identifying Auto-Tensioner Pushrod Extension Limit</u> Courtesy of MITSUBISHI MOTOR SALES OF AMERICA.

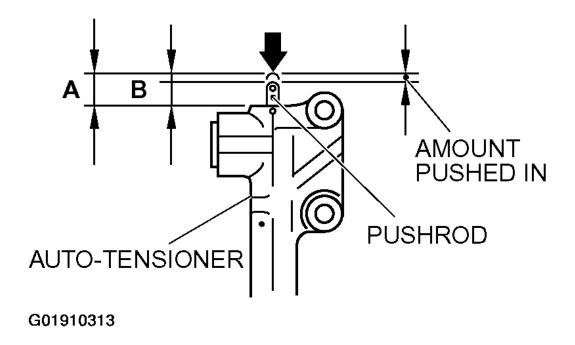
A - B: Amount pushed in

Fig. 62: Identifying Auto-Tensioner Pushrod Pushed In Amount Courtesy of MITSUBISHI MOTOR SALES OF AMERICA.

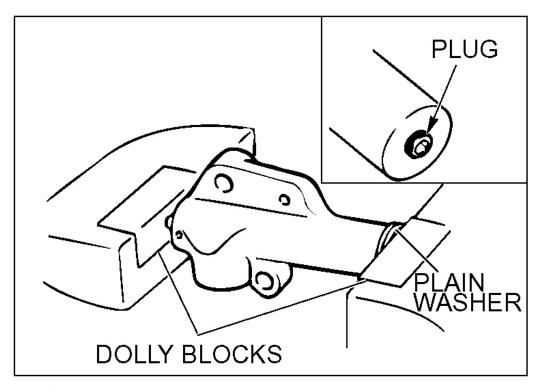
- Place the auto-tensioner perpendicular to the jaws of the vice.
- If there is a plug at the base of the auto-tensioner, insert a plain washer onto the end of the auto-tensioner to protect the plug.
- 2. If it is not within the standard value, replace the auto-tensioner.
- 3. Place two dolly blocks in a vice as shown in the illustration, and then place the auto-tensioner in the vice.

Fig. 63: Compressing Auto-Tensioner With Vice Courtesy of MITSUBISHI MOTOR SALES OF AMERICA.

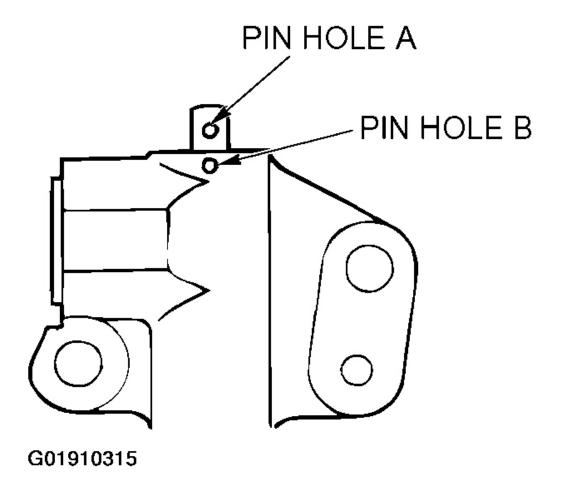
4. Slowly compress the pushrod of the auto-tensioner until pin hole A in the pushrod is aligned with pin hole B in the cylinder.

<u>Fig. 64: Identifying Auto-Tensioner Pin Holes</u> Courtesy of MITSUBISHI MOTOR SALES OF AMERICA.

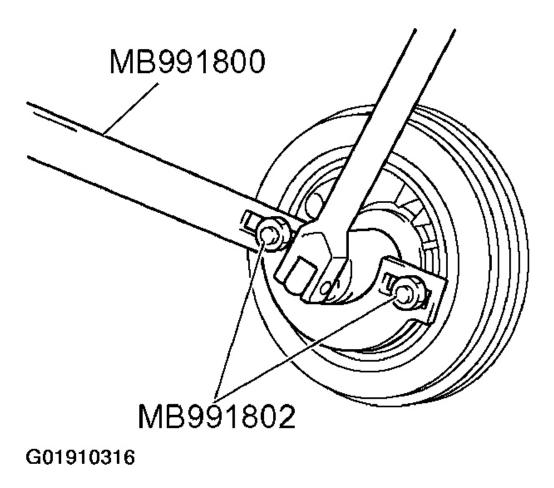
Use special tools MB991800 and MB991802 to install the crankshaft pulley.

<u>Fig. 65: Installing Crankshaft Pulley</u> Courtesy of MITSUBISHI MOTOR SALES OF AMERICA.

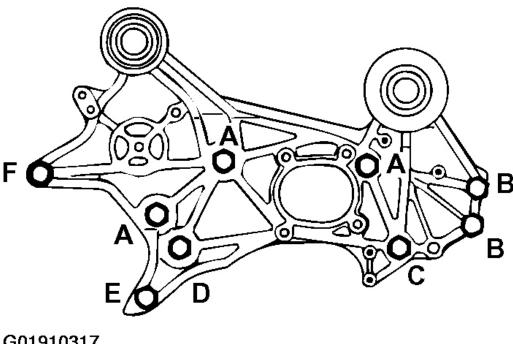
Install the bolts to the shown positions, and tighten them to the specified torque.

<u>Fig. 66: Identifying Accessory Mount Assembly Bolt Installation Sequence</u> Courtesy of MITSUBISHI MOTOR SALES OF AMERICA.

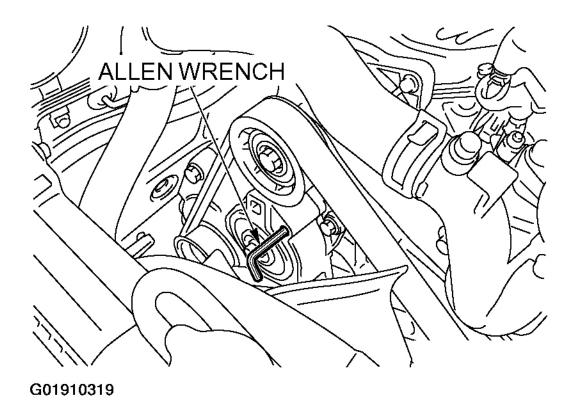
- 1. Install the drive belt auto tensioner with the Allen wrench inserted.
- 2. After the drive belt has been installed, remove the Allen wrench while holding the drive belt auto tensioner with a socket wrench drive. Then release the drive belt auto tensioner slowly.

<u>Fig. 68: Removing Allen Wrench From Tensioner</u> Courtesy of MITSUBISHI MOTOR SALES OF AMERICA.

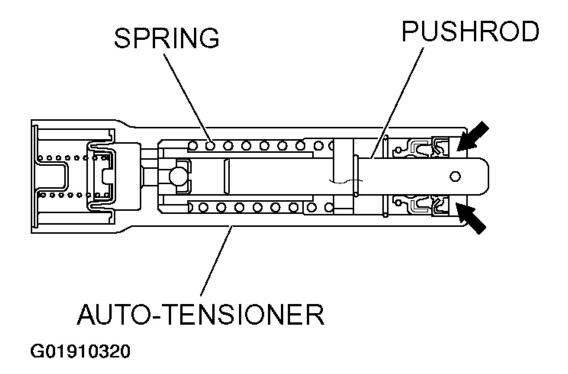
- Check the auto-tensioner for possible leaks.
- Check the pushrod for cracks.

<u>Fig. 69: Inspecting Auto-Tensioner</u> Courtesy of MITSUBISHI MOTOR SALES OF AMERICA.
