2008 ENGINE Engine Mechanical - Lancer Evolution

# **GENERAL INFORMATION**

The 4B11 (2.0 L) engine is an in-line four-cylinder engine. The cylinder numbers are assigned as 1-2-3-4 from the front of the engine (timing belt side). The firing order is 1-3-4-2.

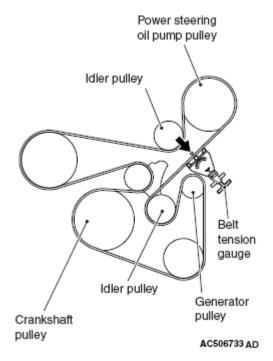
Fig. 5: Locating Tension Of Drive Belt Courtesy of MITSUBISHI MOTOR SALES OF AMERICA.

**Standard value: 248 - 400 N (56 - 90 lb)**

3. If not within the standard value, replace the auto-tensioner. (Refer to **TIMING CHAIN**).

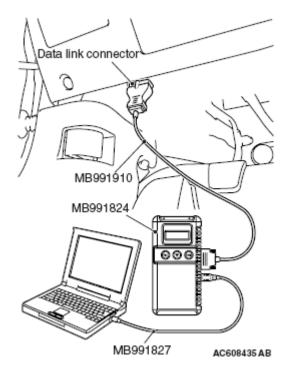
Fig. 6: Connecting Scan Tool MB991958 To Data Link Connector Courtesy of MITSUBISHI MOTOR SALES OF AMERICA.

2. Connect scan tool MB991958 to the data link connector.

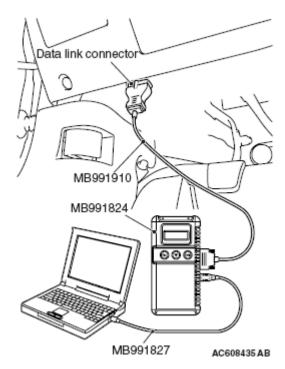
2. Connect scan tool MB991958 to the data link connector.

<u>Fig. 8: Connecting Scan Tool MB991958 To Data Link Connector</u> Courtesy of MITSUBISHI MOTOR SALES OF AMERICA.

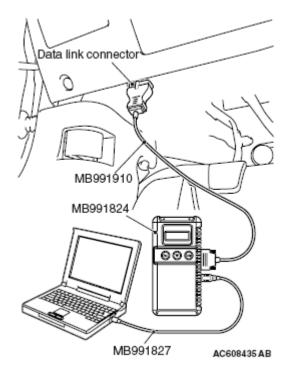
2. Connect scan tool MB991958 to the data link connector.

<u>Fig. 10: Connecting Scan Tool MB991958 To Data Link Connector</u> Courtesy of MITSUBISHI MOTOR SALES OF AMERICA.

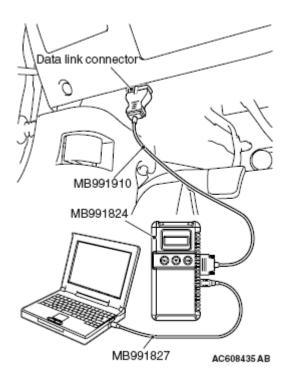
<u>Fig. 14: Connecting Scan Tool MB991958 To Data Link Connector</u> Courtesy of MITSUBISHI MOTOR SALES OF AMERICA.

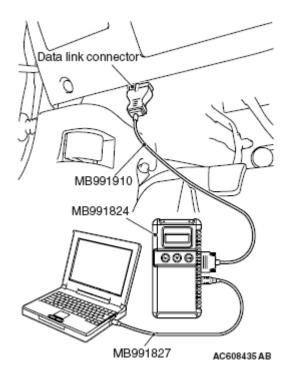
2. Connect scan tool MB991958 to the data link connector.

<u>Fig. 15: Connecting Scan Tool MB991958 To Data Link Connector</u> Courtesy of MITSUBISHI MOTOR SALES OF AMERICA.

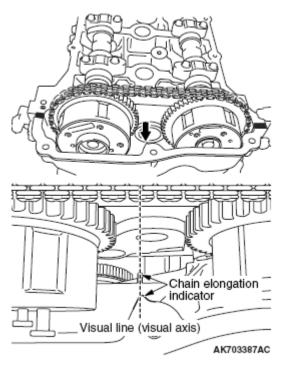
Fig. 18: Identifying Chain Elongation Indicator And Visual Line Courtesy of MITSUBISHI MOTOR SALES OF AMERICA.

5. Look at the inside of timing chain case with one eye in the direction of arrow shown in the illustration. Fix the eye line at the point where the top axis line of the chain elongation indicator at the front side of timing chain case is overlapped with that of the chain elongation indicator at the reverse side of timing chain case.

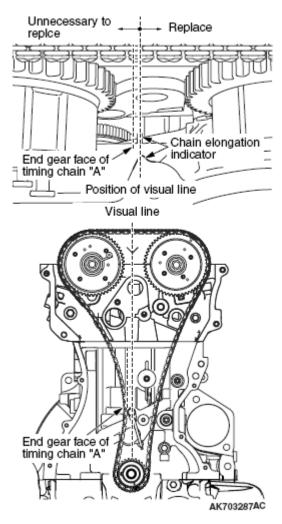
Fig. 19: Identifying Visual Line Of Timing Chain
Courtesy of MITSUBISHI MOTOR SALES OF AMERICA.

6. Check the end top point "A" of timing chain cross section surface and the point of chain elongation indicator which is fixed in Step 5. When the end top point "A" of timing chain is positioned at the left-hand side of chain elongation indicator, it is unnecessary to replace the timing chain because the timing chain is within the specified length. When the end top point "A" of timing chain is positioned at the right-hand side of chain elongation indicator, it is necessary to replace the timing chain because the timing chain elongates more than the specified length.

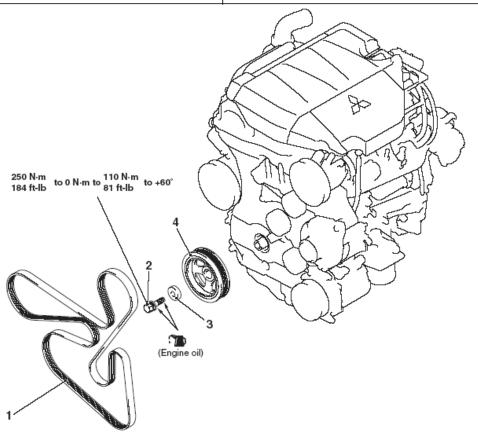
AC704354AC Removal steps Removal steps (Continued) Engine mounting bracket >>**B**<< 1. <<A>>> Drive belt <<B>> >>**A**<< 2. Crankshaft pulley center bolt 2. 3. <<B>> >>A<< Crankshaft pulley washer >>A<< 4. Crankshaft pulley

Fig. 22: Identifying Crankshaft Pulley Components With Torque Specifications Courtesy of MITSUBISHI MOTOR SALES OF AMERICA.

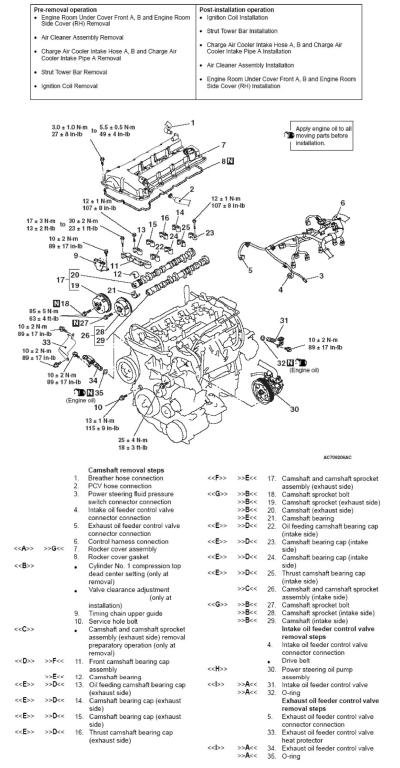
Fig. 32: Exploded View Of Camshaft With Torque Specifications Courtesy of MITSUBISHI MOTOR SALES OF AMERICA.

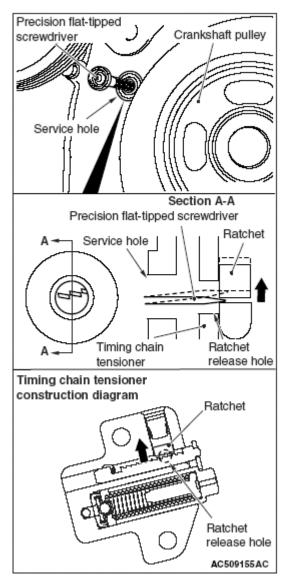
Fig. 35: Identifying Cylinder Head Upper Surface And Camshaft Sprocket Timing Marks Courtesy of MITSUBISHI MOTOR SALES OF AMERICA.

1. Insert a precision flat-tipped screwdriver through the service hole of the timing chain case, press up the timing chain tensioner ratchet to unlock, and keep the timing chain tensioner with that state.

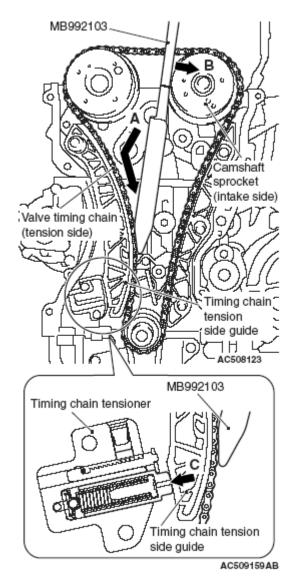
Fig. 37: Identifying Timing Chain Tensioner And Special Tool (MB992103) Courtesy of MITSUBISHI MOTOR SALES OF AMERICA.

3. With the special tool inserted up to the insertion guide line, press the special tool against the intake side camshaft sprocket and spread and hold the timing chain tension side guide.

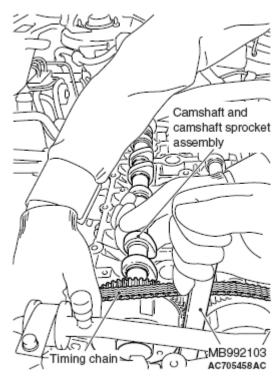
<u>Fig. 42: Removing Timing Chain From Camshaft And Camshaft Sprocket Assembly (Exhaust Side)</u>
Courtesy of MITSUBISHI MOTOR SALES OF AMERICA.

2. Remove the timing chain from the camshaft and camshaft sprocket assembly (exhaust side) toward the timing chain case assembly, and remove the camshaft and camshaft sprocket assembly (exhaust side) toward the transaxle.

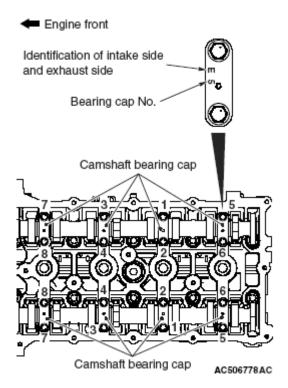
Fig. 48: Identifying Camshaft Bearing Cap Mounting Bolt Tighten Sequence Courtesy of MITSUBISHI MOTOR SALES OF AMERICA.

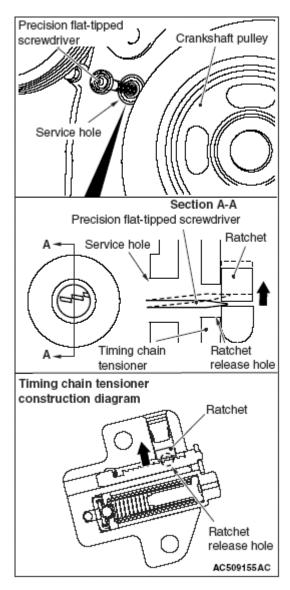
Fig. 51: Identifying Ratchet Release Hole, Ratchet And Service Hole Courtesy of MITSUBISHI MOTOR SALES OF AMERICA.

Lightly press down the tail end of the precision flat-tipped screwdriver to press up the tip of the precision flat-tipped screwdriver inserted to the timing chain tensioner to unlock.

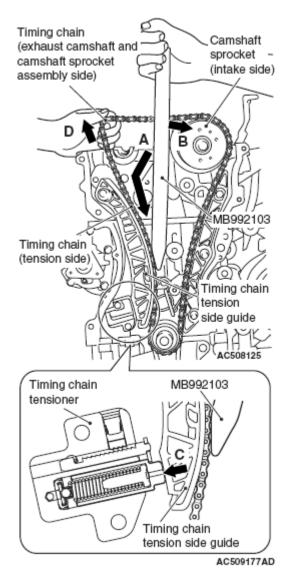
Fig. 53: Pressing Special Tool Intake Side Camshaft Sprocket And Timing Chain Tension Side Guide

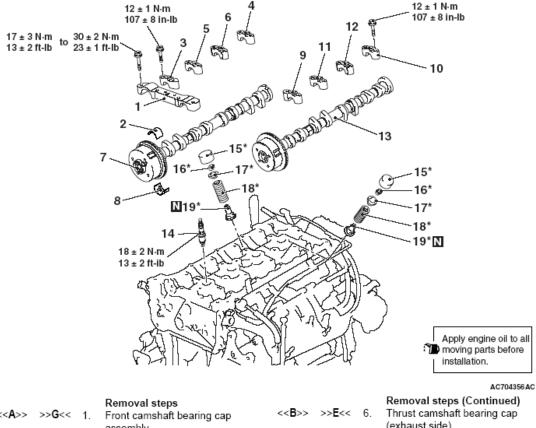
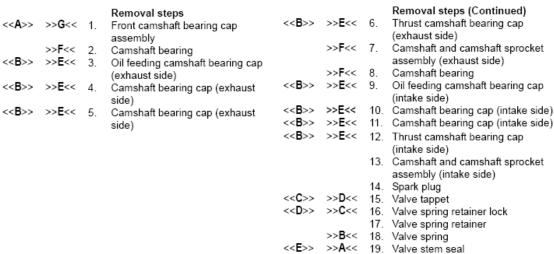
<u>Fig. 58: Identifying Camshaft Components With Torque Specifications</u> Courtesy of MITSUBISHI MOTOR SALES OF AMERICA.

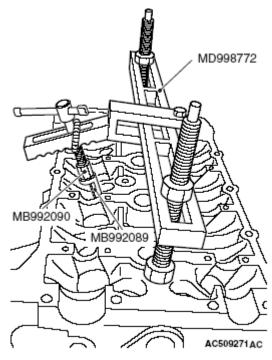
<u>Fig. 62: Identifying Special Tool MB992090 To Special Tool MD998772 And Special Tool MB992089</u>

2. Install special tool MD998772 (with special tools MB992090 and MB992089 attached) to the cylinder head and compress the valve spring. Then, remove the valve spring retainer lock.

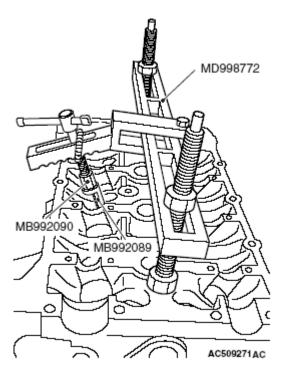
In the same manner as removal, use special tool MD998772 with special tool MB992090 and special tool MB992089 attached to compress the valve spring, and install the valve spring retainer lock.

Fig. 67: Identifying Special Tool MB992090 To Special Tool MD998772 And Special Tool MB992089 Courtesy of MITSUBISHI MOTOR SALES OF AMERICA.

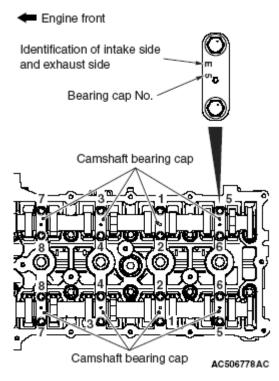
Fig. 69: Identifying Camshaft Bearing Cap Mounting Bolt Tighten Sequence Courtesy of MITSUBISHI MOTOR SALES OF AMERICA.

Tightening torque:  $12 \pm 1$  N.m  $(107 \pm 8 \text{ in-lb})$

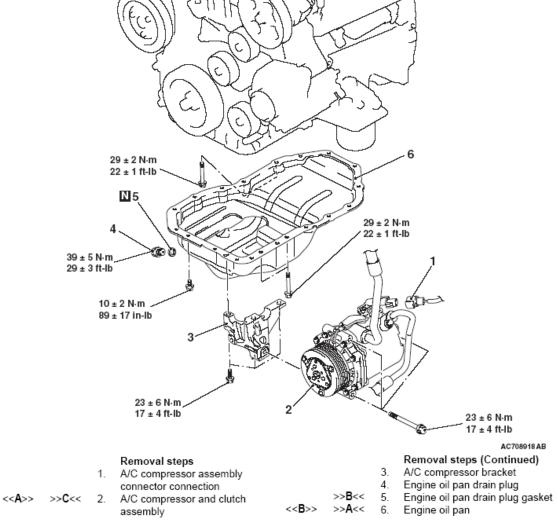
<u>Fig. 73: Exploded View Of Oil Pan With Torque Specifications</u> Courtesy of MITSUBISHI MOTOR SALES OF AMERICA.

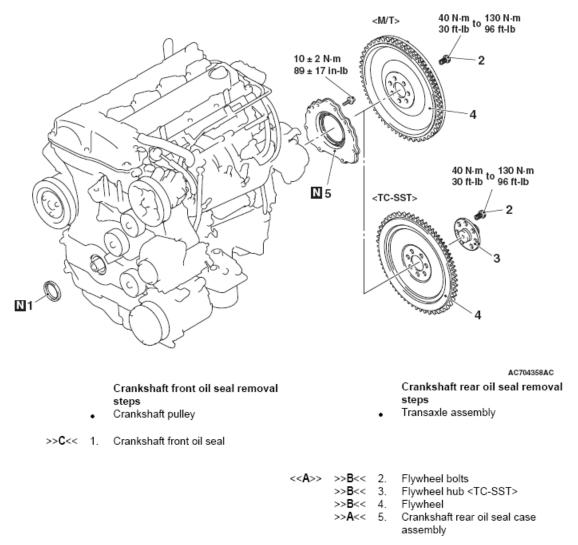
<u>Fig. 80: Identifying Crankshaft Oil Seal And Components With Torque Specifications</u> Courtesy of MITSUBISHI MOTOR SALES OF AMERICA.

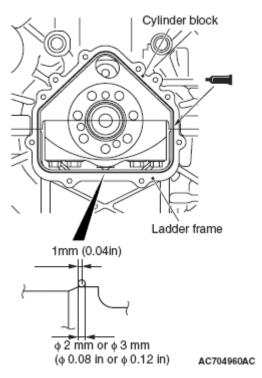
Fig. 82: Identifying Crankshaft Rear Oil Seal Case Assembly Courtesy of MITSUBISHI MOTOR SALES OF AMERICA.

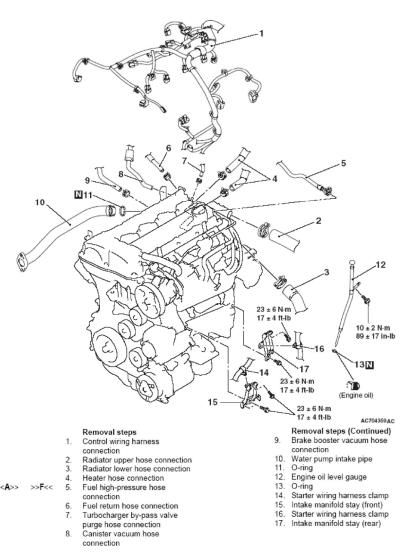
<u>Fig. 87: Identifying Cylinder Head Gasket And Components With Torque Specifications (1 Of 2)</u> Courtesy of MITSUBISHI MOTOR SALES OF AMERICA.

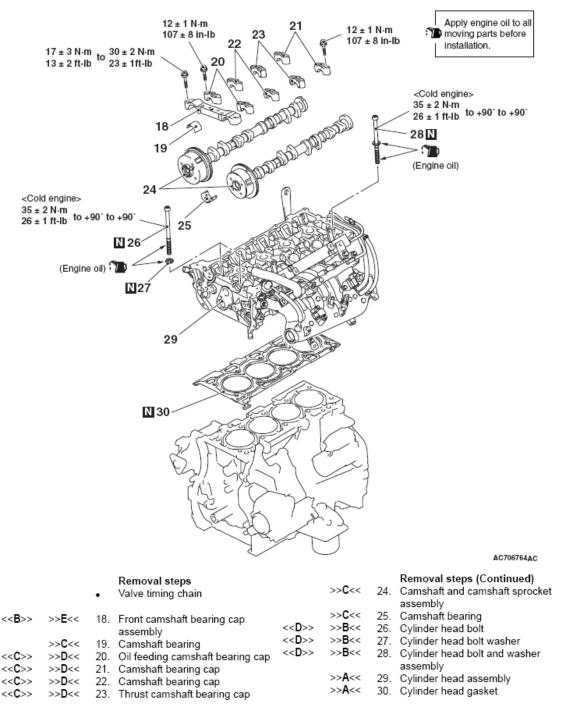
<u>Fig. 88: Identifying Cylinder Head Gasket And Components With Torque Specifications (2 Of 2)</u> Courtesy of MITSUBISHI MOTOR SALES OF AMERICA.

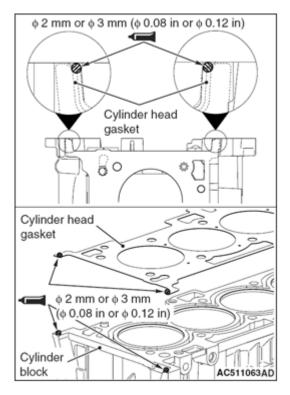
Fig. 98: Identifying Cylinder Head Gasket Sealant Area Courtesy of MITSUBISHI MOTOR SALES OF AMERICA.

CAUTION: Within two hours after the cylinder head assembly installation, do not apply oil or water to the sealant application area or start the engine.

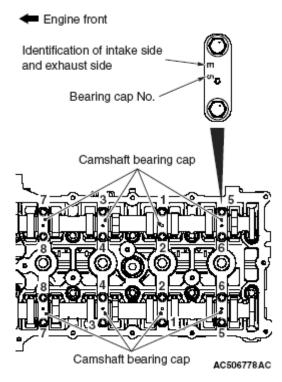
Fig. 105: Identifying Camshaft Bearing Cap Mounting Bolt Tighten Sequence Courtesy of MITSUBISHI MOTOR SALES OF AMERICA.

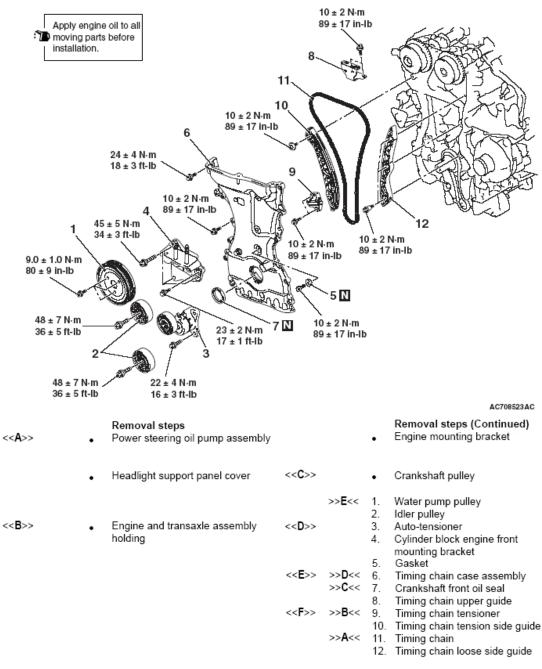
Fig. 108: Identifying Timing Chain Components With Torque Specifications Courtesy of MITSUBISHI MOTOR SALES OF AMERICA.

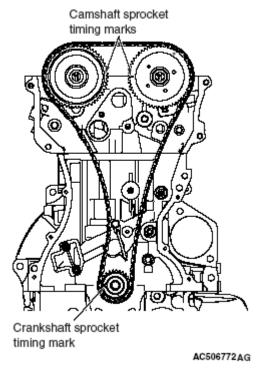
NOTE: At this time, it is not necessary that the link plate (blue) of the timing chain always aligns with each sprocket timing mark.

<u>Fig. 118: Identifying Crankshaft Sprocket Timing Mark</u> Courtesy of MITSUBISHI MOTOR SALES OF AMERICA.

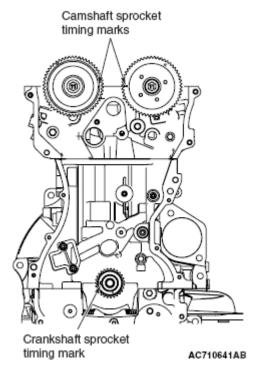
<u>Fig. 120: Identifying Crankshaft Sprocket Timing Mark</u> Courtesy of MITSUBISHI MOTOR SALES OF AMERICA.

1. Set the timing marks of the camshaft sprockets and the crankshaft sprocket as shown in the figure.

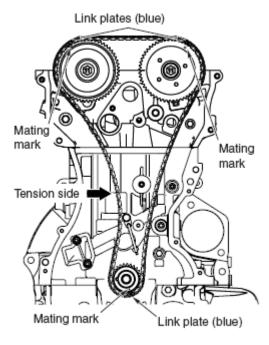
AC506772 AP

Fig. 121: Identifying Mating Mark With Link Plate Courtesy of MITSUBISHI MOTOR SALES OF AMERICA.

2. Align each sprocket timing chain mating mark with the link plate (blue) of timing chain to avoid slack of the timing chain tension side, and install the timing chain to the sprockets.

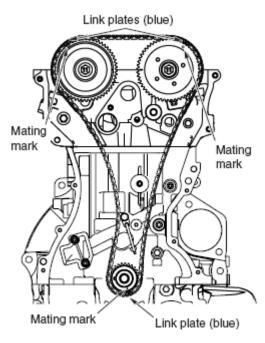
AC506772 AQ

1. Check that the sprocket timing chain mating marks align with the link plates (blue) of the timing chain, and install the timing chain tensioner to the cylinder block.

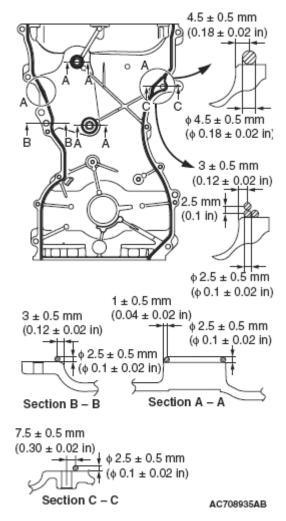
Fig. 125: Identifying Timing Chain Case Assembly Mating Surface Courtesy of MITSUBISHI MOTOR SALES OF AMERICA.

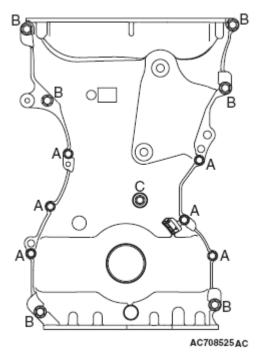
<u>Fig. 126: Identifying Timing Chain Case Assembly Mounting Bolts</u> Courtesy of MITSUBISHI MOTOR SALES OF AMERICA.

| Flange bolt (A) | M6 x 25 | $10 \pm 2 \text{ N.m } (89 \pm 17 \text{ in-lb})$ |
|---|---|---|
| Bolt (C) | M6 x 25 | $10 \pm 2 \text{ N.m } (89 \pm 17 \text{ in-lb})$ |

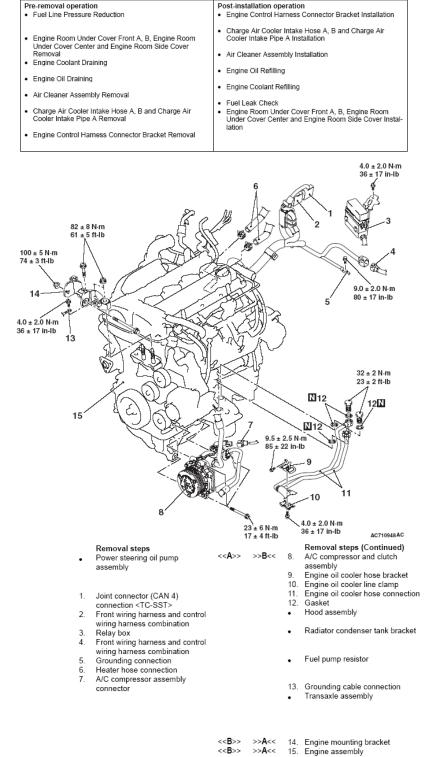
Fig. 127: Identifying Engine Assembly With Torque Specifications Courtesy of MITSUBISHI MOTOR SALES OF AMERICA.
